SKAPS INDUSTRIES

CASE STUDY ON SBC CANAL

The Saurashtra Branch Canal (SBC) is the largest branch of Narmada Project Canal System, which off takes from Narmada Main Canal at Ch. 263.20 km near Kadi District - Mehsana and has a length of 104.46 km, and it tails in Bhogavo - II Irrigation Scheme (Dholi Dhaja dam) near Surendranagar.

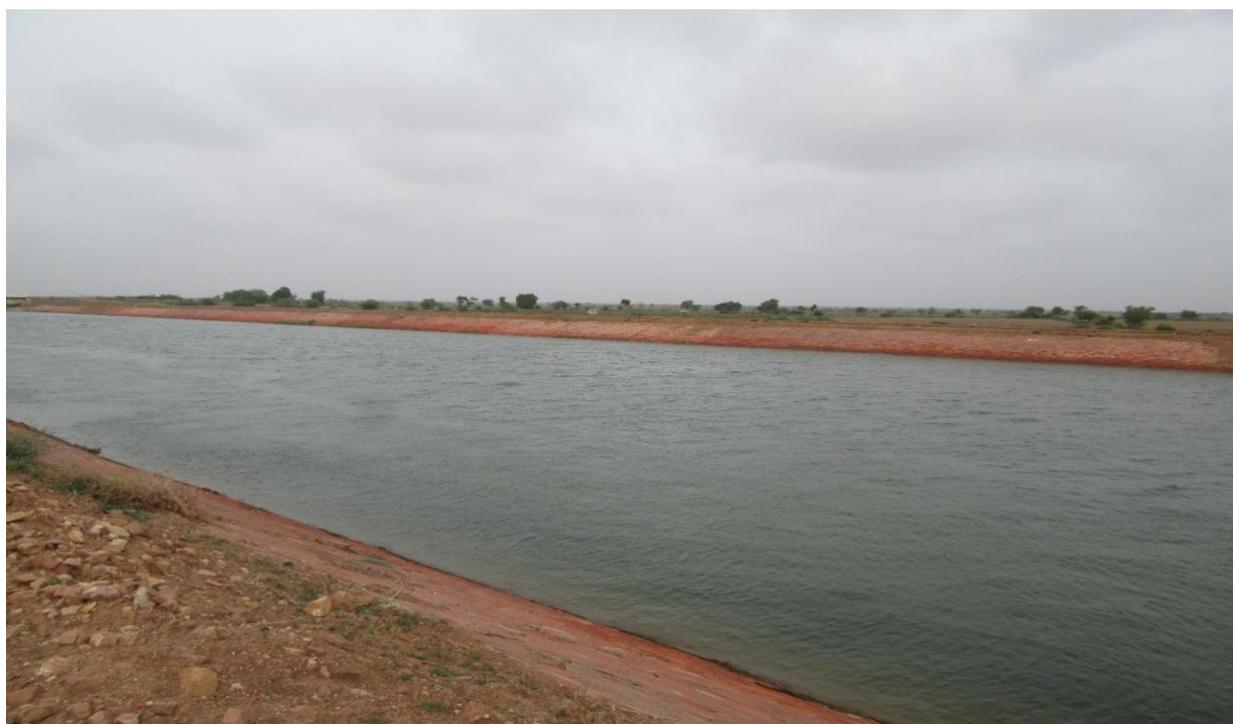
The Saurashtra Branch Canal is quite a large system and in addition the system is complex and unique in nature that involves the passage of canal through a constantly falling ground in more than half of its initial reach and rising ground in the subsequent reach to Bhogavo - II Irrigation Scheme where it tails.

The canal is in banking from chainage 54120 m. to chainage 63540 m. Due to irrigation and drinking water supply to Saurashtra and Kutch region, this canal is being operated as perennial canal. Stoppage of water supply for regular maintenance is almost impossible considering the drinking water supply services being rendered by this canal system.

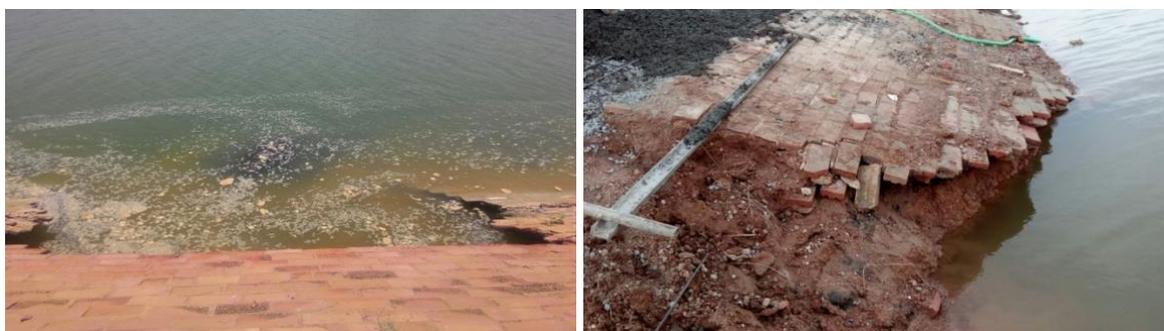
The canal is in full banking in about 9 to 10 Km. length. The existing canal is having brick/tile lining, constructed about 15 years back. The efficacy of the brick/tile lining is to be re-examined. It was also observed that there are few stretches, particularly in the reaches of high banking, vulnerable to slippage, resulting into severe leakages and this can ultimately lead to breaches. SBC is a perennial canal and in absence of any comprehensive inspection and assessment of canal slopes and beds, it is very difficult to take precautions to prevent the damage.

As the flow in the canal is not to be reduced or stopped, conventional strengthening measures in the vulnerable stretches cannot be applied. Any repairing or strengthening activity, particularly for the section below water level needs to be carried out under flowing water condition.

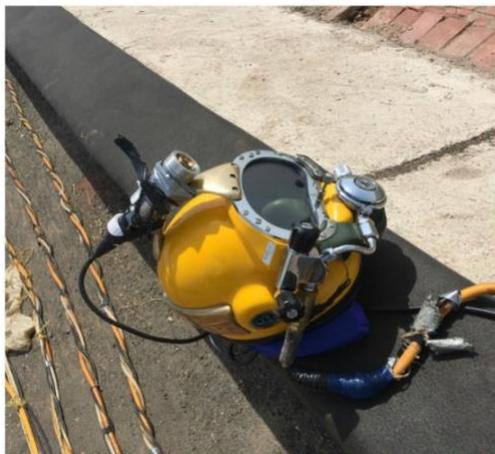
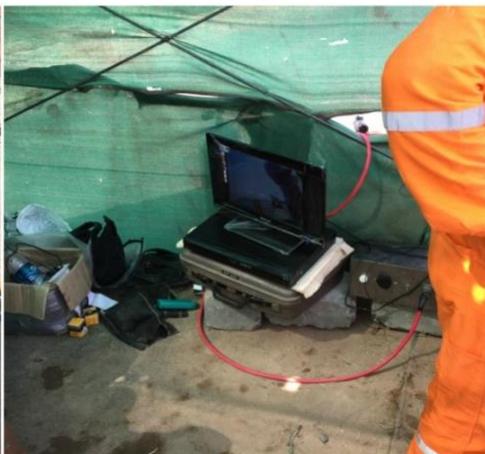
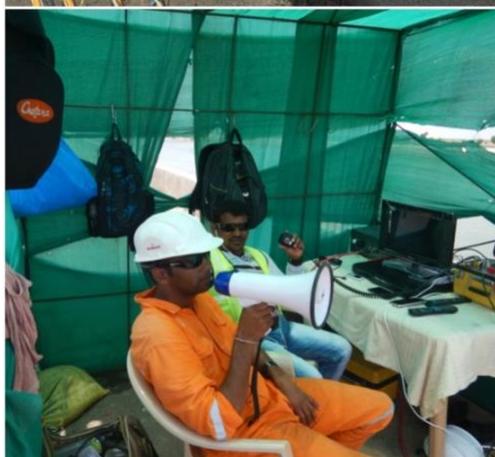
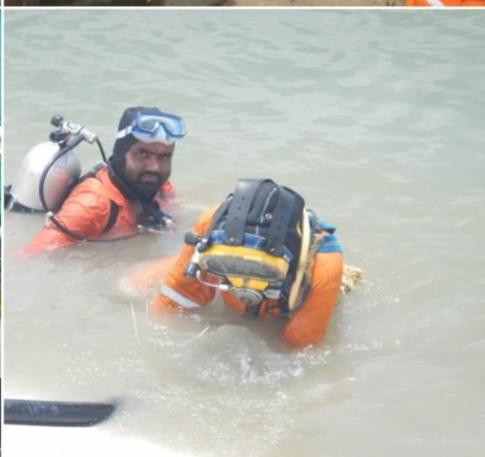
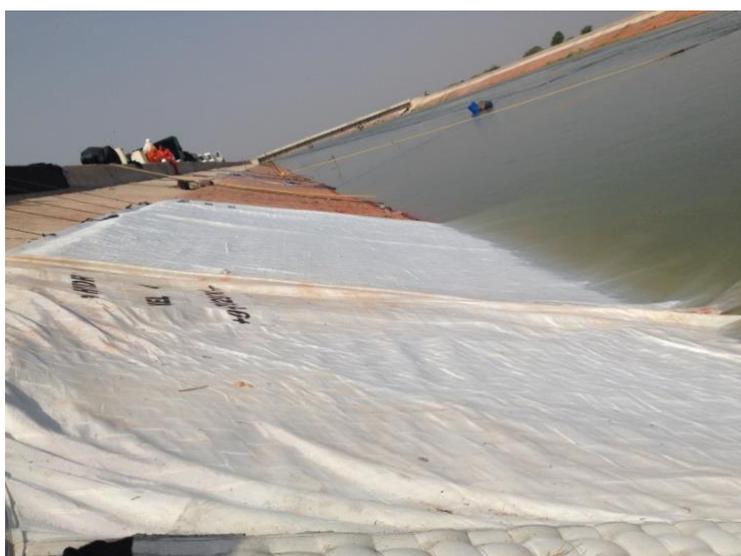
As the canal is in operation since years and record of the present condition about silting along the bed is not available, it is proposed to carry out under water inspection and also to have the bed profiling done through appropriate equipment's. Debris, stones, vegetation and siltation was cleared and removed before laying the nonwoven geotextile and uniform section form fabric.

After the canal slopes and bed are cleaned, dressed and leveled, non-woven geotextile and uniform form fabric section was laid with the help of divers. Panels was connected by zipper and hand-held stitching machine. Anchoring was needed prior to filling the concrete grout in to the fabric form to prevent the sliding of panels into canal.

Once Panel was laid properly, pumpable fine aggregate concrete was transported from RMC to the project site by transit mixer. Filling was done into the fabric by concrete pump at appropriate pressure. Prior to removing the filling pipe from the current concrete lining section and proceeding to the fine aggregate concrete filling of the adjacent lining section, the thickness of the current lining section was measured by inserting a length of stiff wire through the lining at several locations from the crest to the toe of the slope. After the fine aggregate concrete has set, all anchor, flank and toe trenches was backfilled and compacted flush with the top of the concrete lining.

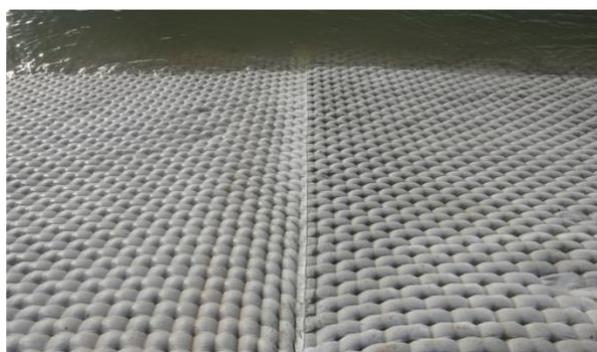
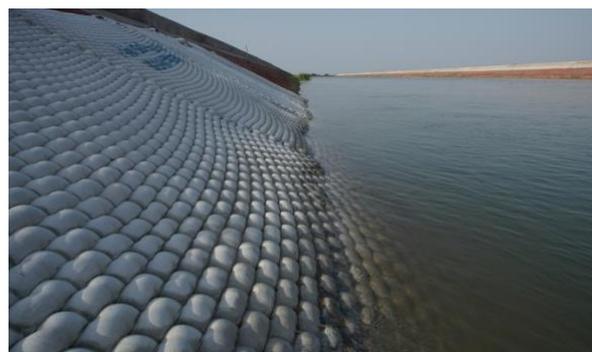
Fabric form mattresses after completion of filling process of grout:
